ITEM	STATUS	COMMENT
Components	Standard	All components according to assembly plan
EEPROM (U2)	NOT PRESENT	
R916	NOT PRESENT	no PEX configuration by I2C
Firmware	Programmed	"generic7-D1111-A1110-L1101-C1100.mcs"
FW switch (SW5)	(1101) RTM_TCLKA PCIe source	for use with LEGACY boards and x16 RTM
J36/J37	ON	
IPMC	NOT PRESENT	
Mechanics	Not Assembled	LED kits assembled
PCIe test	OK	with ATCA-PTSW-AMC4 RTM v2.1 #2 , cable, OSSx4
LEDs	OK	
Current location	IST, Lisbon.

Issues found:

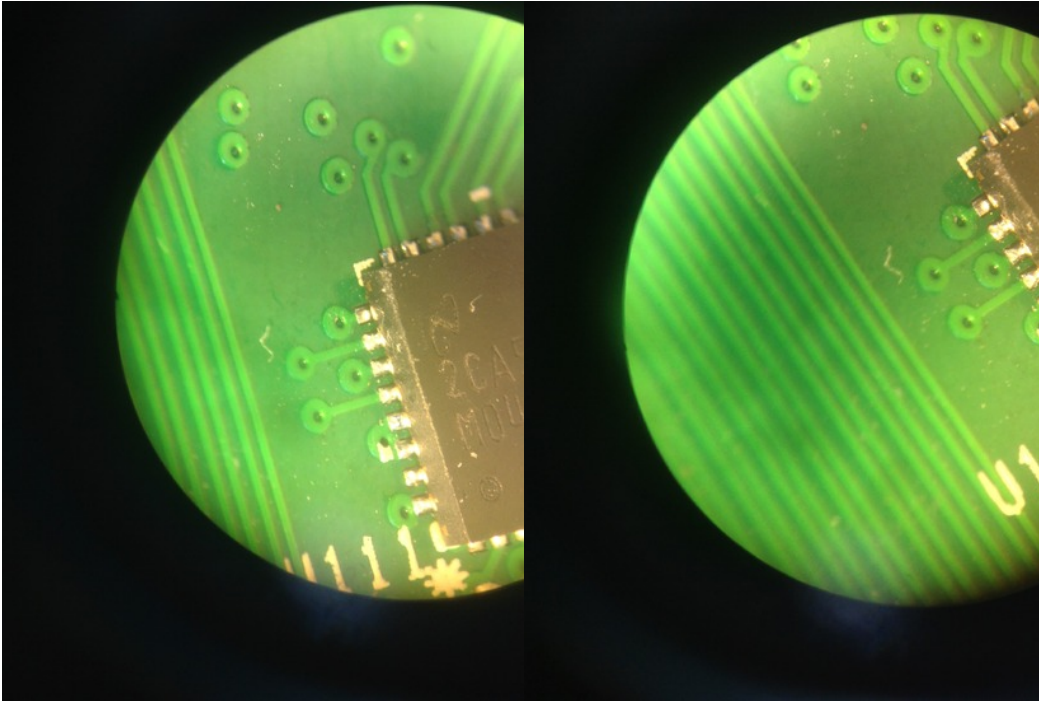
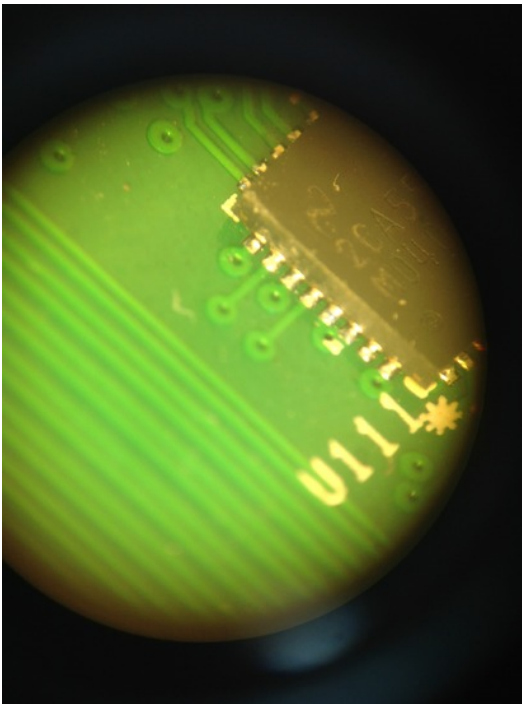
1. Faulty soldering of U111 caused the CLK3A and CLK3B and respective control signals to malfunction and fail the tests with IPFN legacy boards. U111 also shows some unusual surface wear.

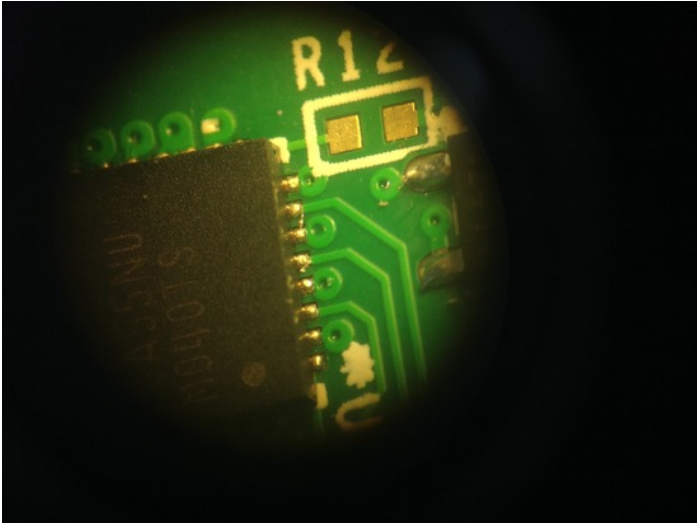
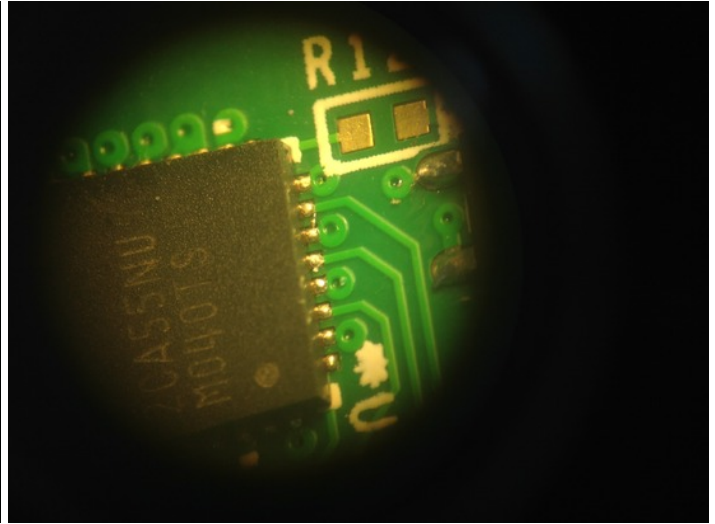
2. Faulty soldering on U100 was detected, as shown on pictures
